IX. Troubleshooting

Flat amplification curve in the amplification curves window (no apparent amplification)

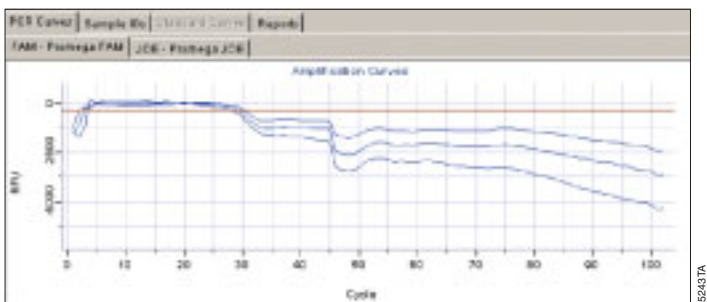
Figure 30. An image showing SDS software version 1.0 data exported to Plexor™ Analysis Software. Note the cycle number on the X axis goes to 100. See Section X.H for programming instructions.
